THE HUMMINGBIRD XV-4B VTOL RESEARCH AIRCRAFT PROGRAM

Lockheed Georgia Company
Marietta, Georgia

TECHNICAL REPORT AFFDL-TR-69-75

OCTOBER 1969

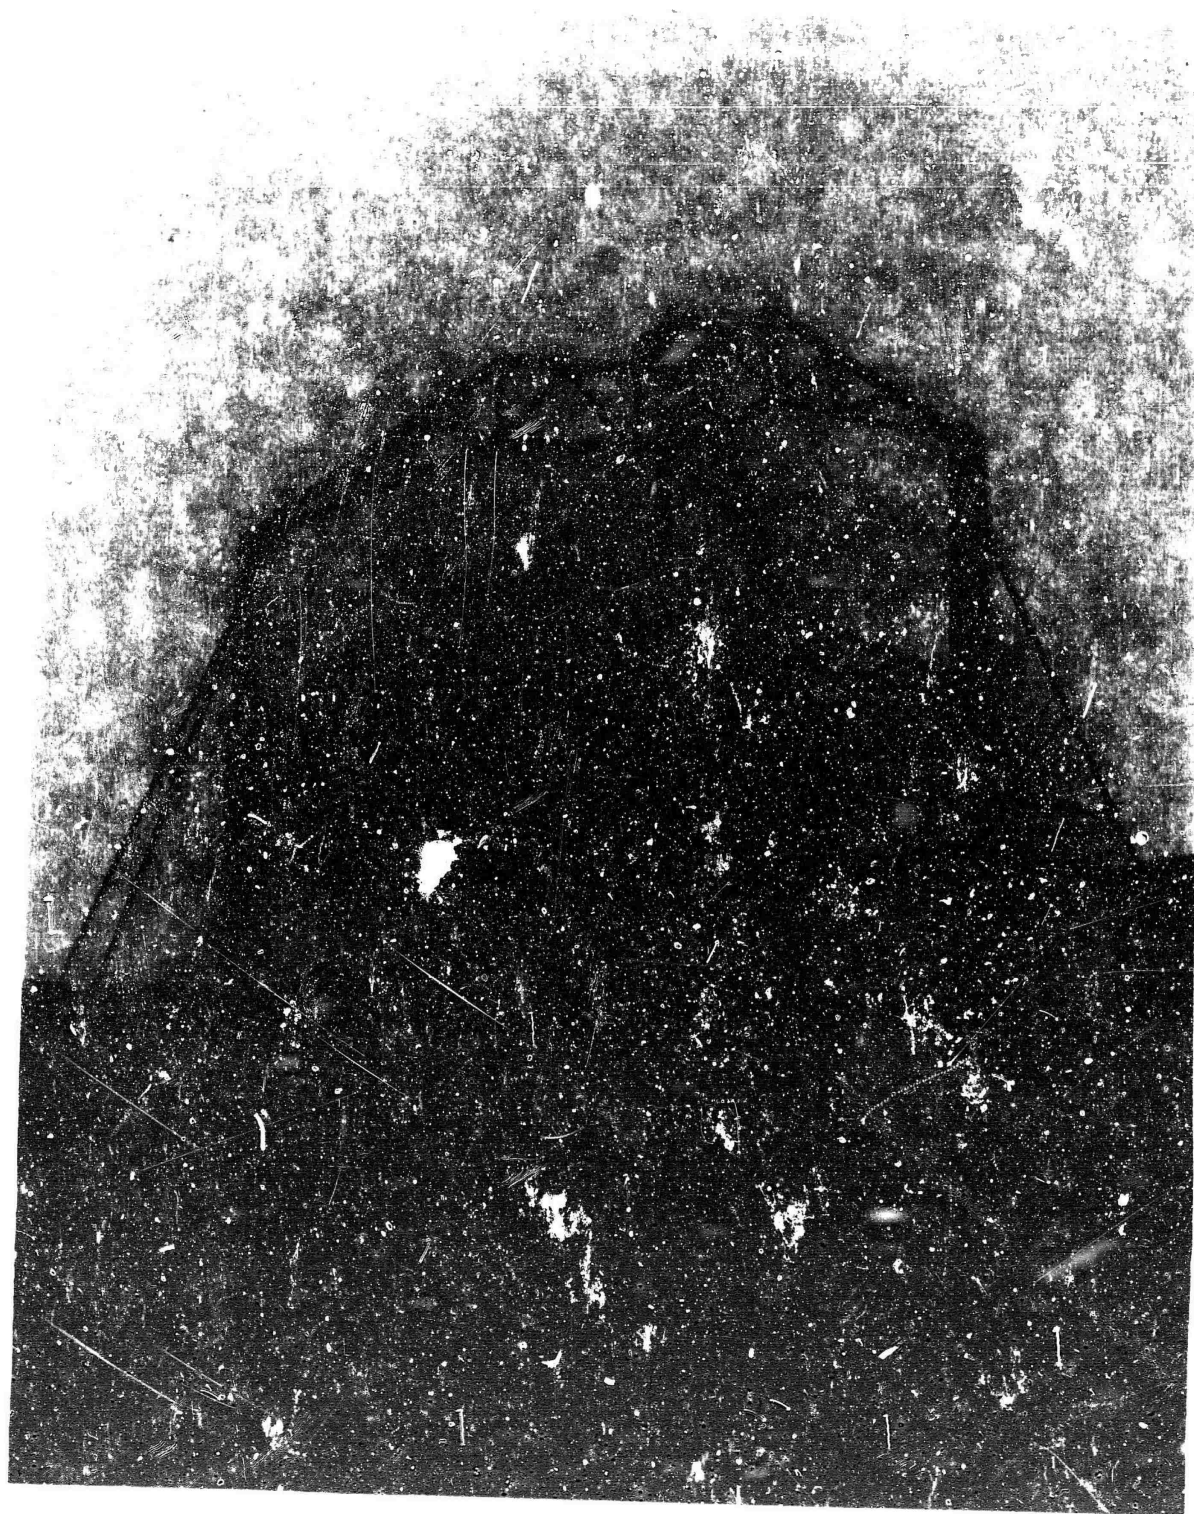
FIGURE 25 - INVERTED TELESCOPE SUPPORTING XV-4B

c. The Aircraft Attachment Linkage consists of a double four-bar linkage, with two horizontal bars pivotally attached to the vertical shaft of the movable framework and two vertical bars extending downward to pivot fittings attached to the aircraft at

the wing roots. A cantilever arm is also pivotally attached to the vertical shaft and extends aft, its free end being linked to an attachment fitting at the base of the aircraft's vertical fin.

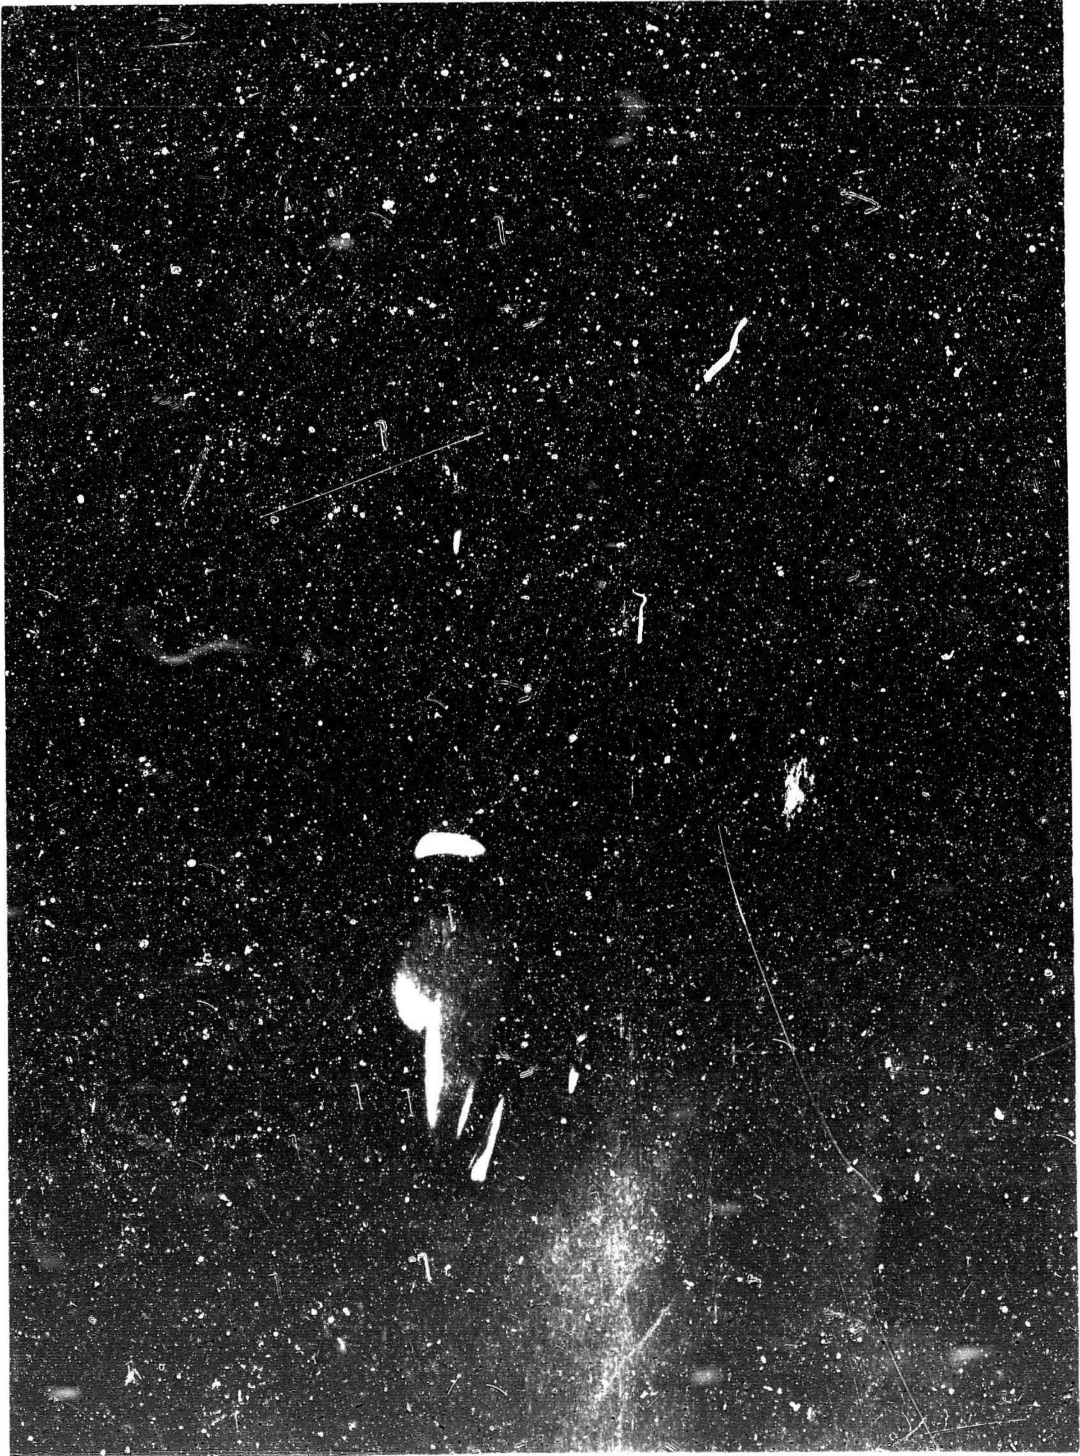
FIGURE 26 - XV-4B WIND TUNNEL MODEL

- (a) Nozzle incidence study in and out of ground effect at zero and low forward velocities
- (b) Horizontal stabilizer effectiveness for various nozzle incidence angles
- (c) Elevator effectiveness
- (d) Effect of inlet and exit doors and landing gear
- (e) Effect of 180 degrees yaw at low velocities

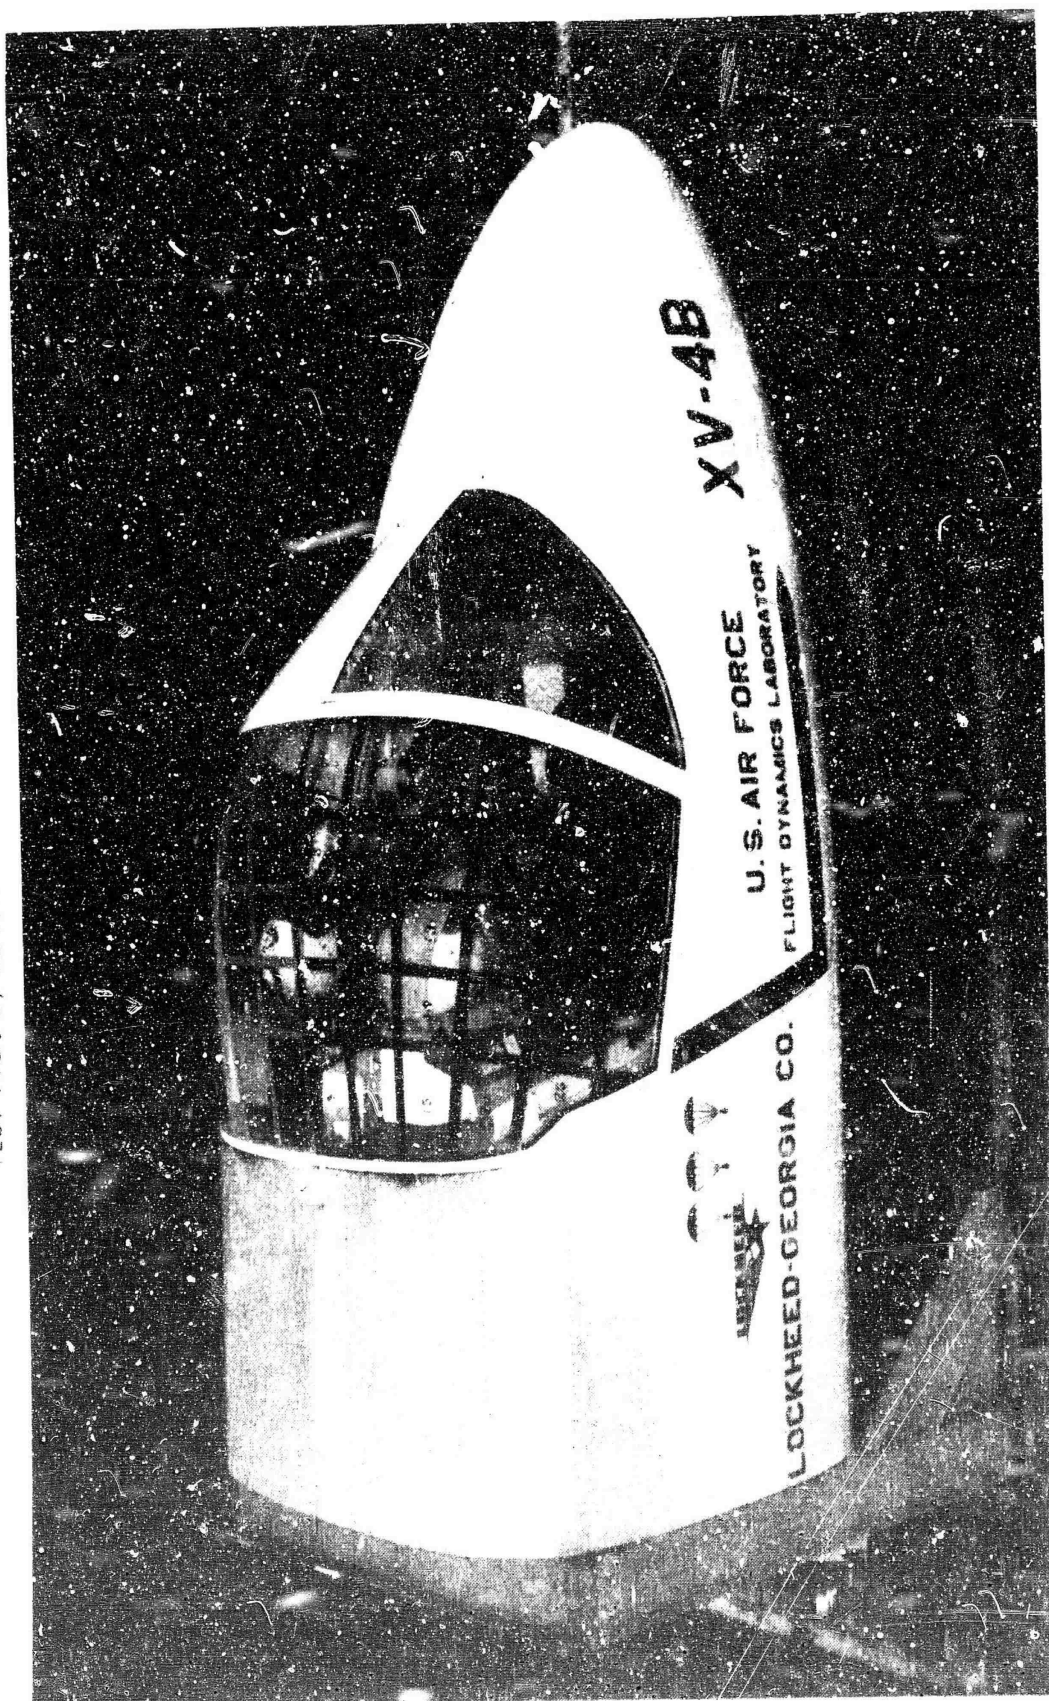
FIGURE 41 - TEST SETUP - COCKPIT TOP VIEW

The testing was conducted utilizing anthropomorphic dummies and using an XV-4B forward fuselage test section, as depicted in Figure 41. With the exception of the last firing, all tests were conducted under static conditions. Instrumentation was principally

TEST NO. 5, REVISED ONE PIECE CANOPY.
